Manhole Inspection Summary

Manhole # S06EE2013MH

Location Address: **7200 CHALKSTONE DR** Cross Street: **SEVEN MILE LN**

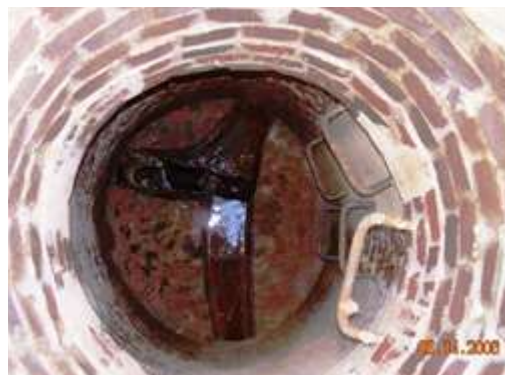
Top View

Adjustment, Corbel and Barrel infiltration.
Evidence of surcharge - Bench debris.
Channel root intrusion.

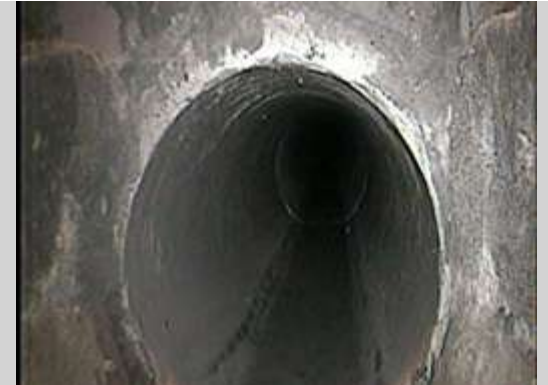
8 in. Circular Gravity Sewer Pipe Out @ 12 O'Clock

Invert Depth: **10.04** (ft.) Flow Characteristics: **Slow**

Infiltration: **None** Pipe Seal Cond: **Unknown**

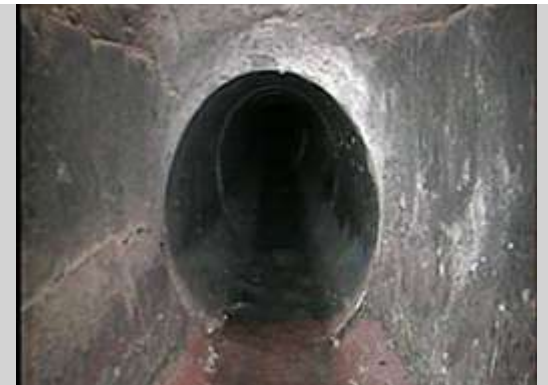
8 in. Circular Gravity Sewer Pipe In @ 6 O'Clock

Invert Depth: **10.09** (ft.) Flow Characteristics: **Slow**

Infiltration: **None** Pipe Seal Cond: **Unknown**

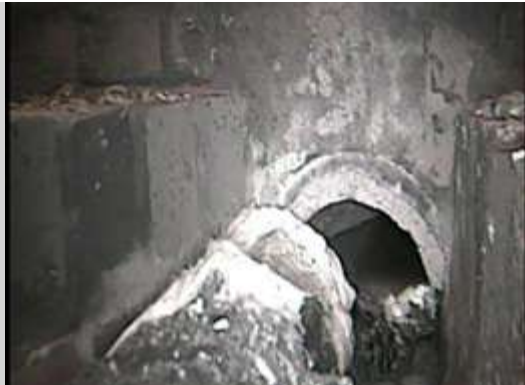
Pipe In @ 9 O'Clock

Channel root intrusion.

Deposits: ☐ None ☒ **Mud** ☐ Sludge ☒ **Debris** ☐ Grease

Silt Depth: **2** (in.) Deposits Extent: **Medium**

Infiltration: **Evidence** Pipe Seal Cond: **Unknown**
